SUCCESS STORY ON CONSTRUCTION OF GABION BOX FOR STREAM BANK EROSION CONTROL

Name of the activity : Stream Bank Erosion control

District: Serchhip

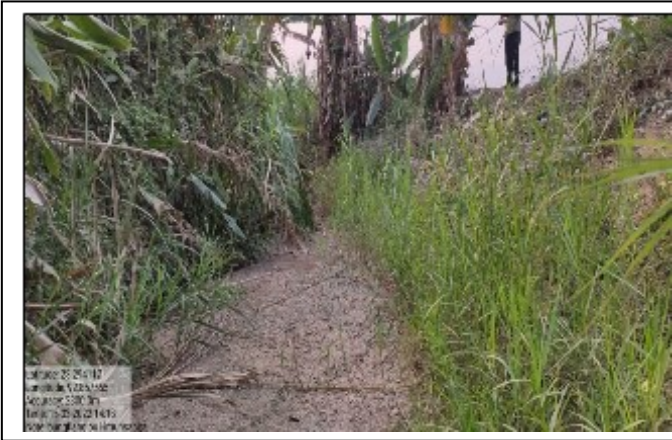
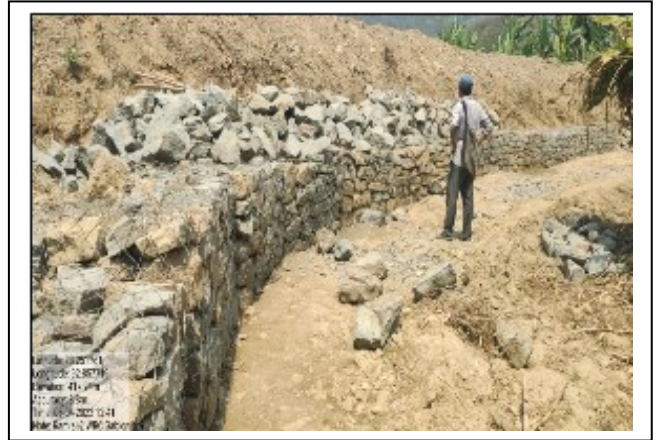
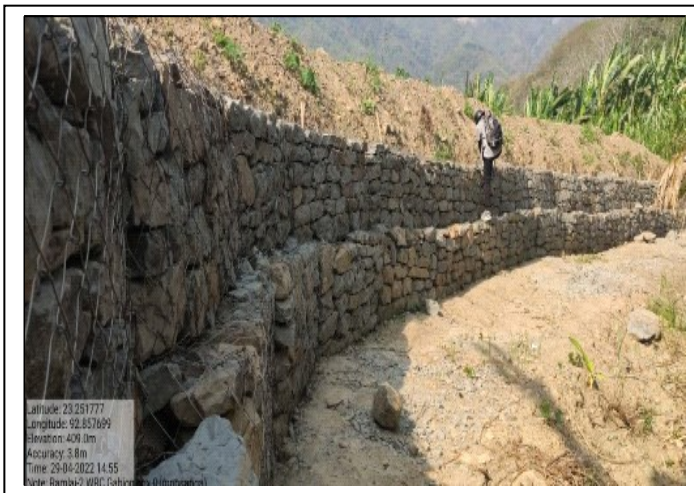
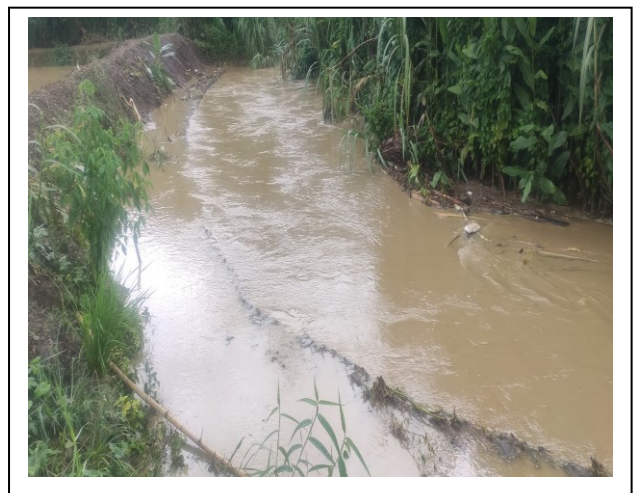
CONSTRUCTION OF GABION BOX: LALHMUNSANGA, SERCHHIP ZAWLPUI

For the stream bank erosion control- Gabion box, stone random rubble masonry and RCC structure Retaining wall was constructed. The rock filled gabions are used to stabilize the stream bank; and also to divert the flow away from the eroding stream section. For bank protection the gabions are constructed in the form of mattresses with the help of one layer of rock encased by suitable gage wire. The gabion mattresses can be used at unstable streambeds and stream banks for preventing soil scouring/washing.

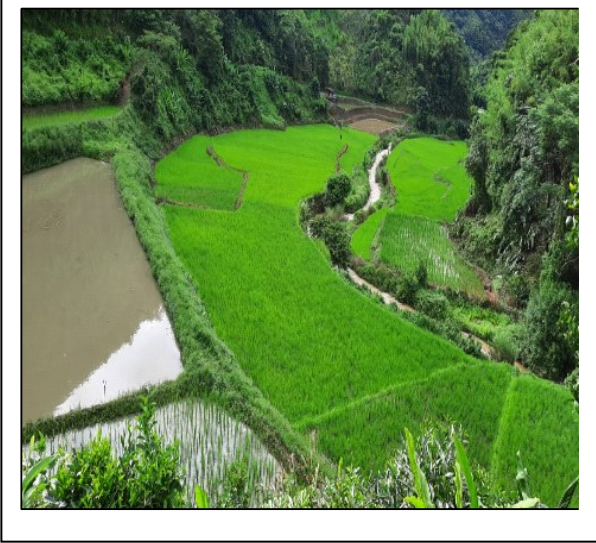
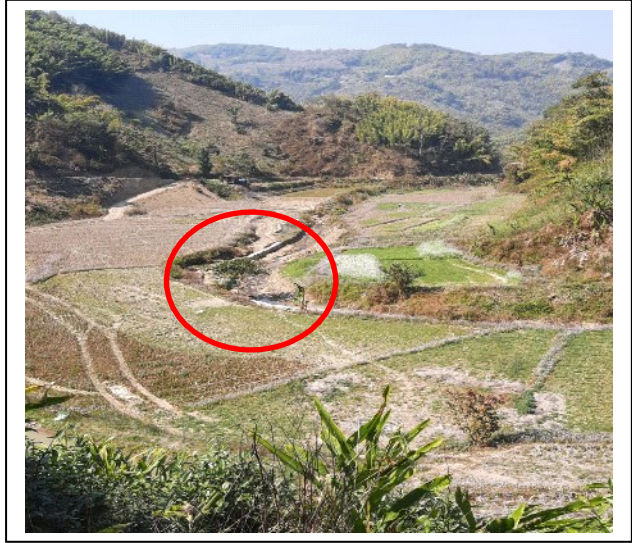
Stream line straightening to reduce soil erosion at WRC area, Chekawn

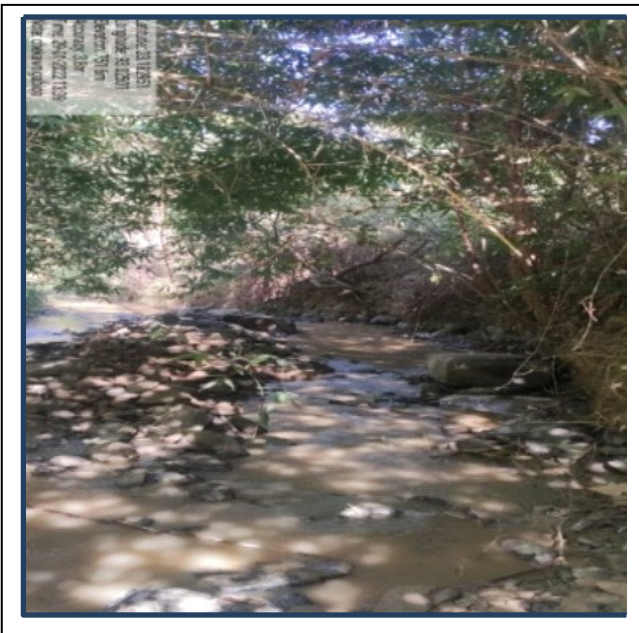
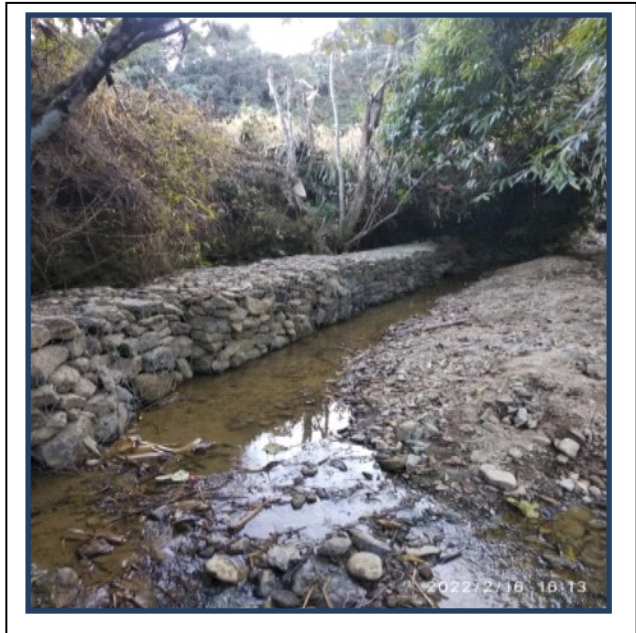
Before and After construction of Gabion Box at Chekawn (C.Vanlalhruaia)
